Title: Recovery of Space Shuttle *Columbia* and Return to Flight of Space Shuttle
Discovery

Organization: NASA

Michael U. Rudolph
Engineering Director
Marshall Space Flight Center

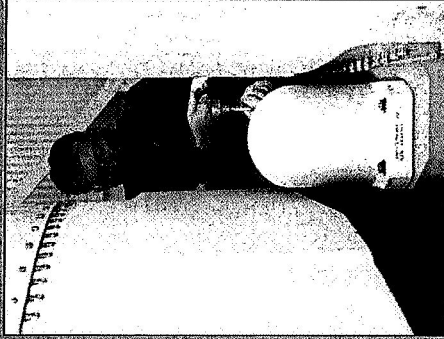
SRB bolt catcher

- Original design load did not include dynamic effects on energy absorber crush strength.
- Possible debris sources included SLA-561 thermal protection material, attach fasteners, or insert failure.
- New design uses cork as TPS material and has passed factor of safety testing.

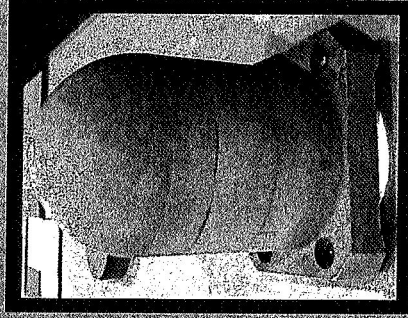
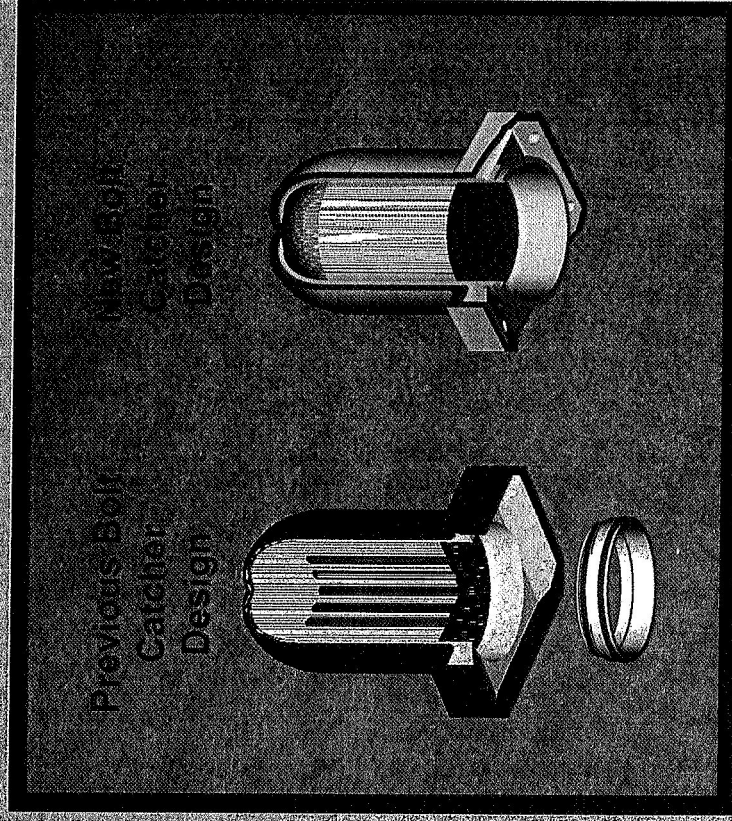
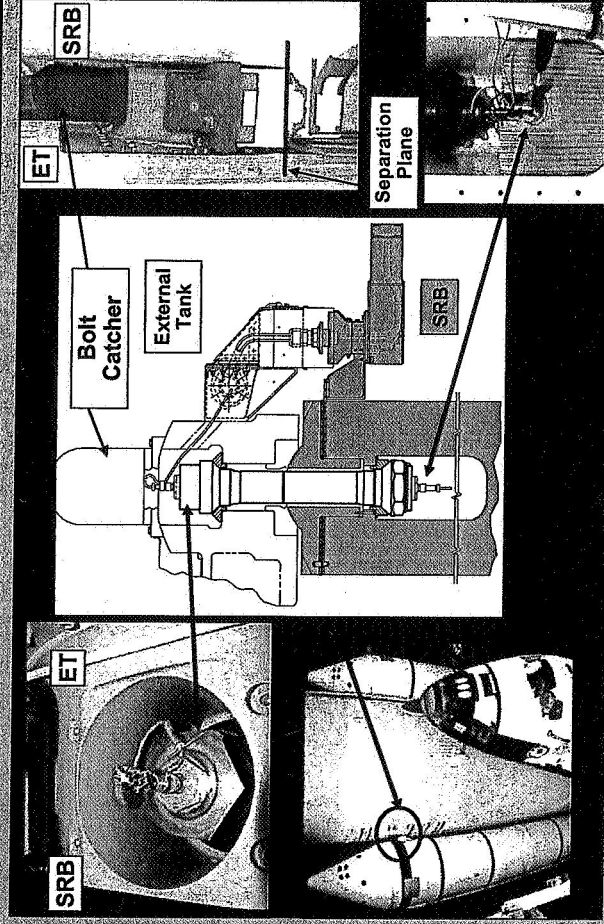
Bolt Catcher NSIPC Redesign

- Bolt catcher redesigned to increase margin of safety
- NSI pressure cartridge redesigned to eliminate NSI ejection

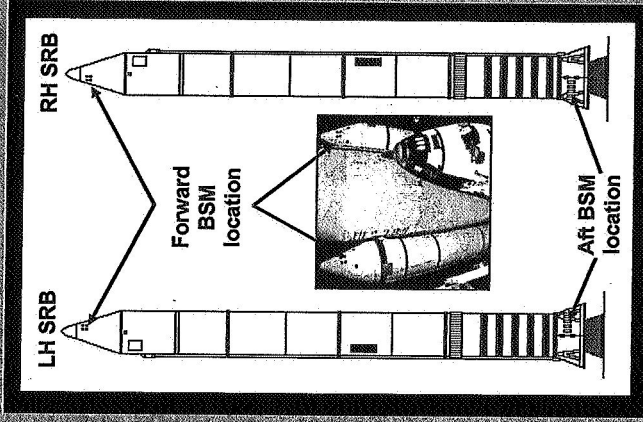
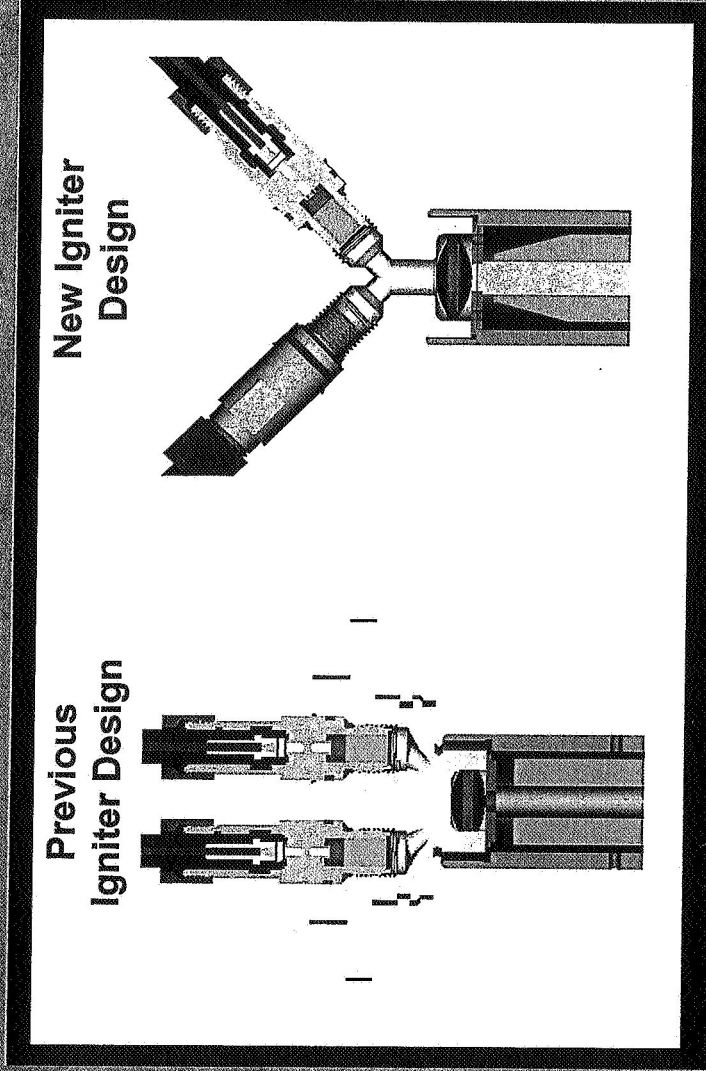
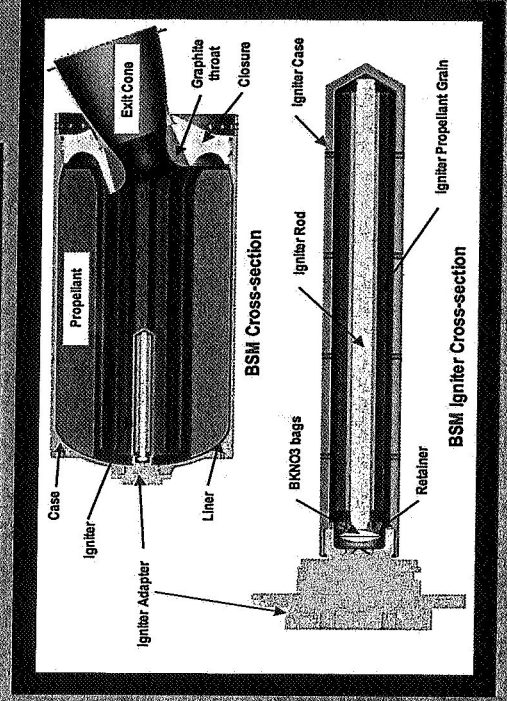
Booster Separation Motor (BSM) Igniter Redesign

- **Booster Separation Motor Igniter redesigned to eliminate erratic performance**

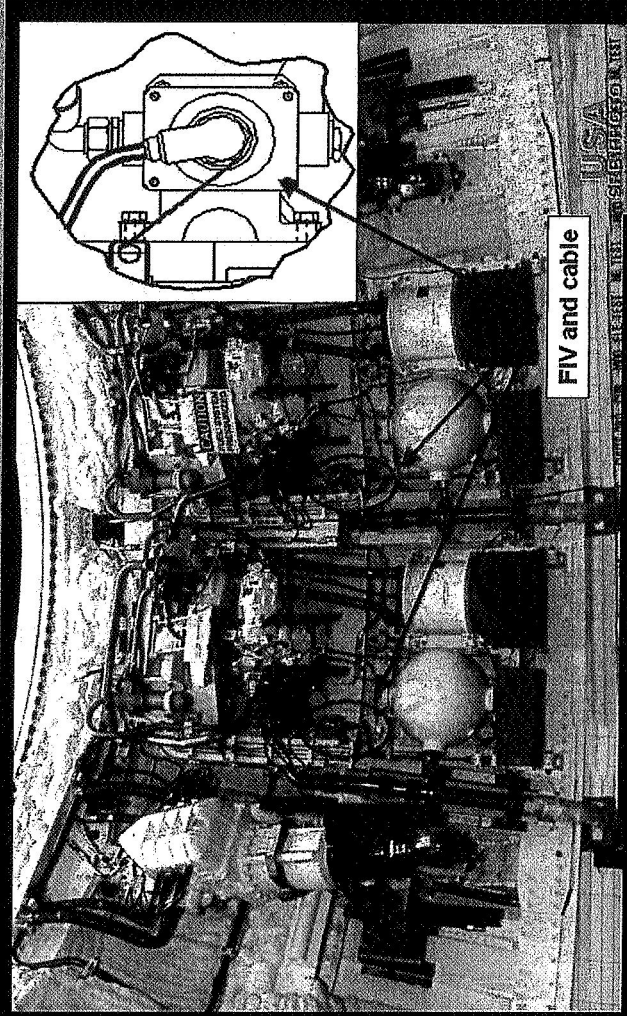
TVC System Typical Installation

- Enhanced cable securing
- New bracket added to installation
- Reduces length for unsupported cable
- Lockwire replaced Loctite on connector threads

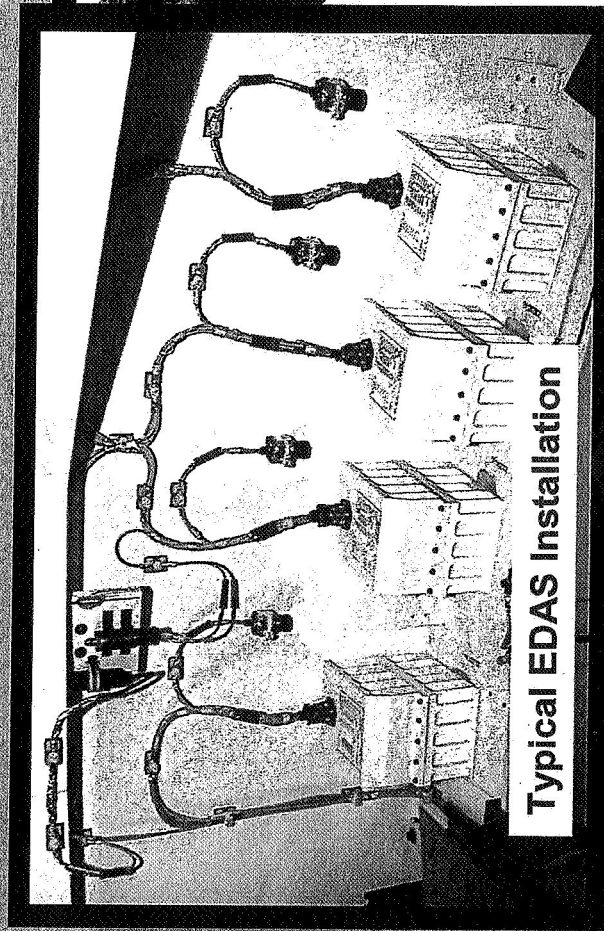
Typical EDAS Installation

- Enhanced Data Acquisition System (EDAS) used to record 13 ET measurements

Bipod Temperatures
(2 RTDs; 2 measurements)

+Z Intertank Accels
(3 accels; 6 measurements)

LO₂ PAL Ramp Accels
(4 accels; 5 measurements)

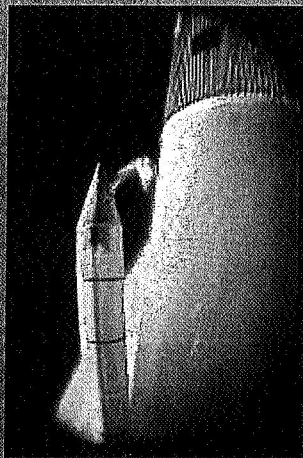
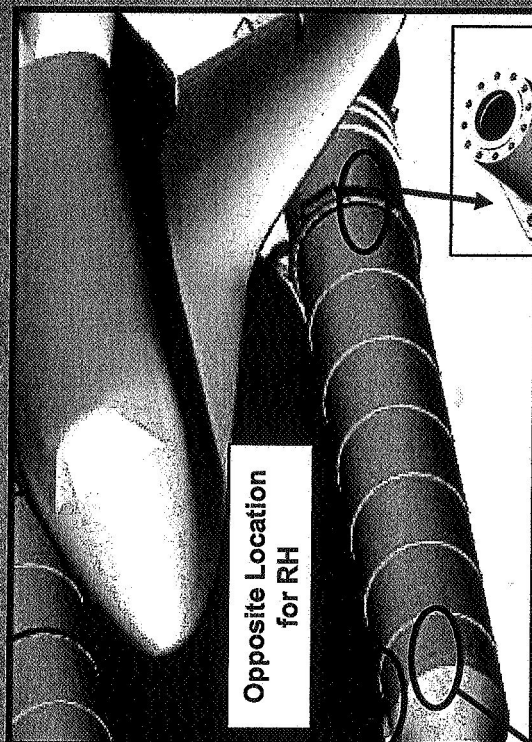
SRB Camera System

Opposite Location
for RH

ET
Observation
Camera

ETA Ring
Camera

Forward
Skirt
Camera
